Notre-Dame de Paris: Pyrolysis Hypothesis and Fire Safety in Historical Buildings

Rémi Desalbres

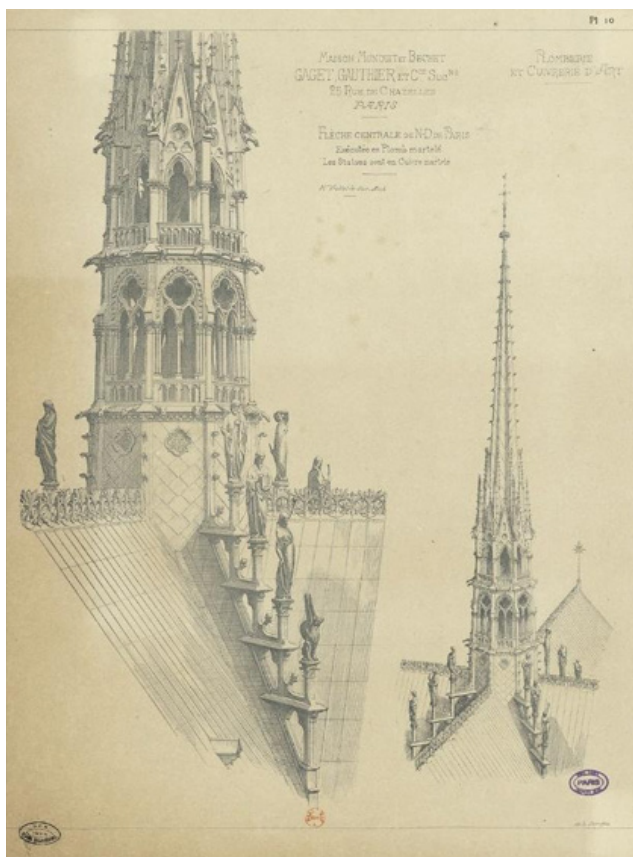
Fig 1. Flèche centrale de N-D de Paris

©Ville de Paris / Bibliothèque historique de la Ville de Paris (BHVP)
The spire, built by Eugène Viollet-le-Duc at the transept crossing, was embellished with sixteen statues, that of the twelve Apostles in the higher parts and the symbols of the four Evangelists at the bottom.

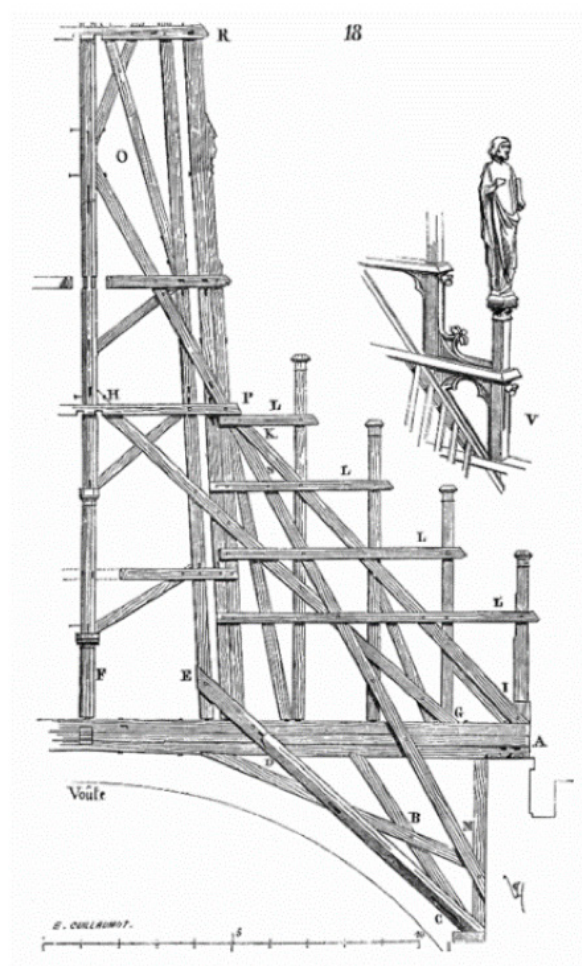
Fig 2. Eugène Viollet-le-Duc, *Dictionnaire raisonné de l'architecture française du XIe au XVIe siècle (1854-1868)*

The statues rested on wooden posts directly connected to the roof timber structure. At the South-East of the crossing, the lowest post supported the Eagle of St John the Evangelist. It was at its base that the fire broke out on 15 April 2019.

In contact with the wall plate, the wooden post supporting the statue of St John's eagle was no longer covered in lead, thus providing the reaction with a large supply of oxygen, a condition favourable to rapid combustion. The photograph taken in the attic by the security guard who discovered the fire confirms the very vigorous nature of the combustion at the foot of the timber roof structure, at the south-east corner of the transept crossing.⁶

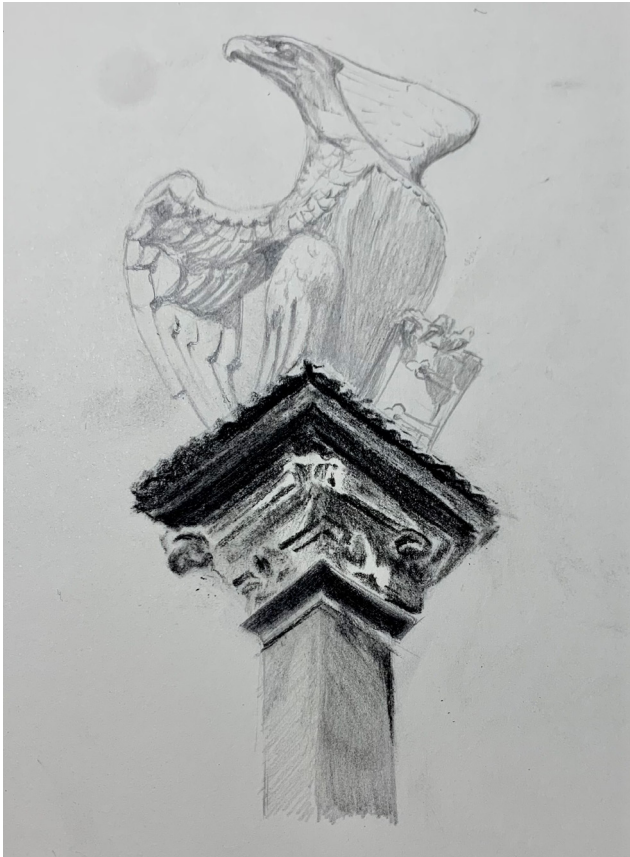
Fig 3. © Joséphine Desalbres

The statues were made of copper leaf after a model by the sculptor Geoffroy-Dechaume. At the foot of the composition, the eagle statue of St John the Evangelist is two metres high.

The Eagle of St John the Evangelist was held at its base by bolts. The support was sealed with shaped lead sheets.

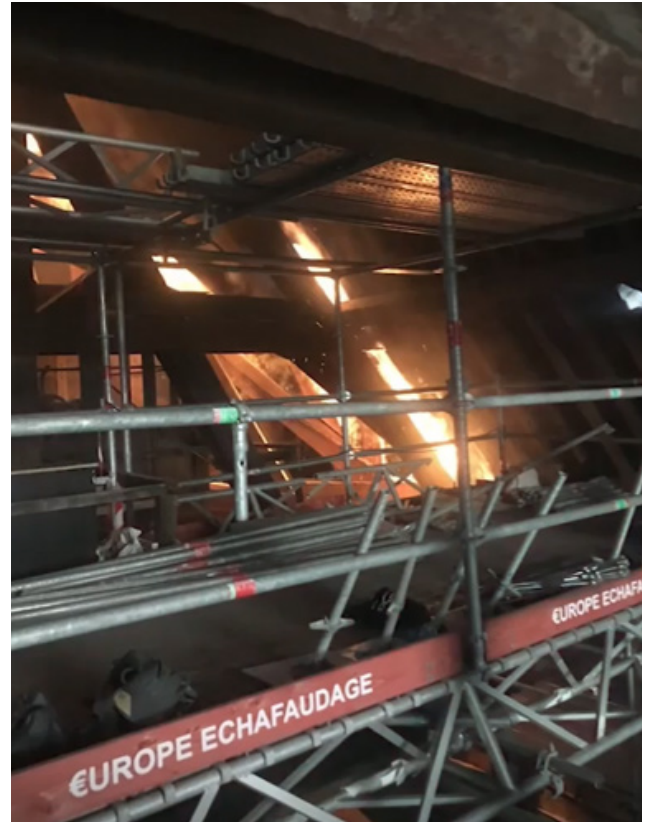
Fig 4. Unique figure of the fire outbreak taken in the attic, at the bottom of the spire. Credit BFMTV.
